Mid-Continent Railway Museum

Duluth, South Shore & Atlantic DULUTH Sleeping Car Restoration

2021 Progress Report

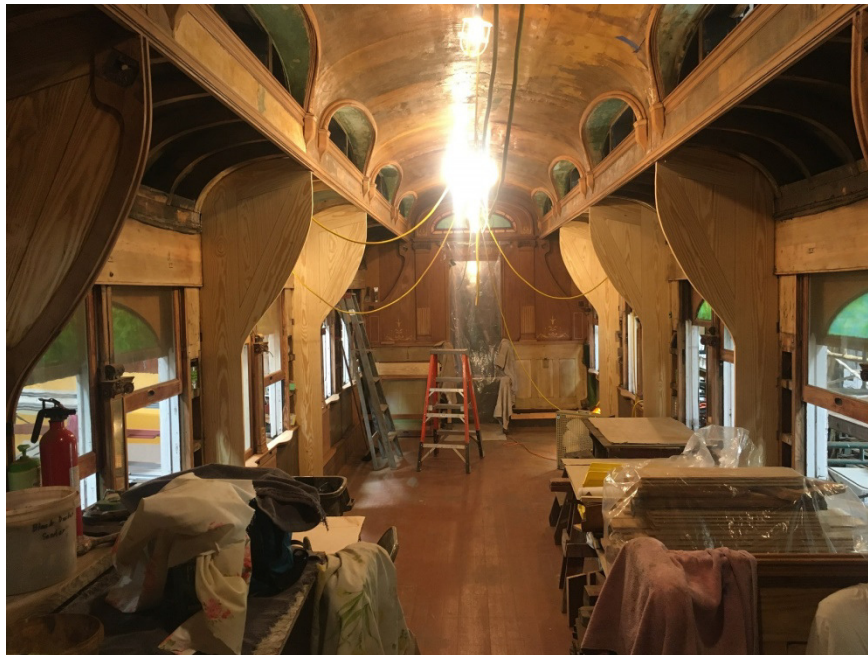
View of the sleeping compartment showing the woodwork that has been stripped during 2021

- All of the old finish (shellac) has been removed from the existing woodwork in the sleeping compartment, men's smoking room and the women's toilet room. This work was performed by hired help due to the extensive scope of this work and the large number of work hours required.

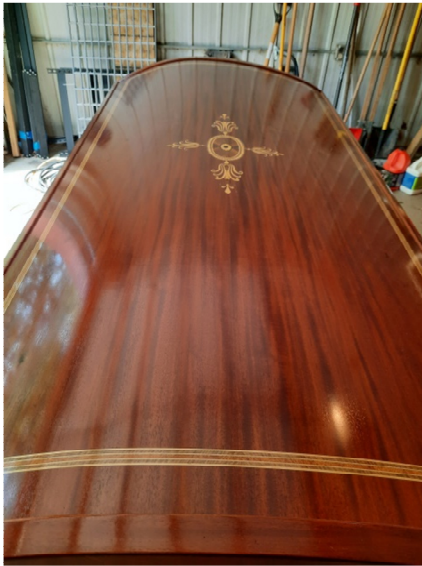
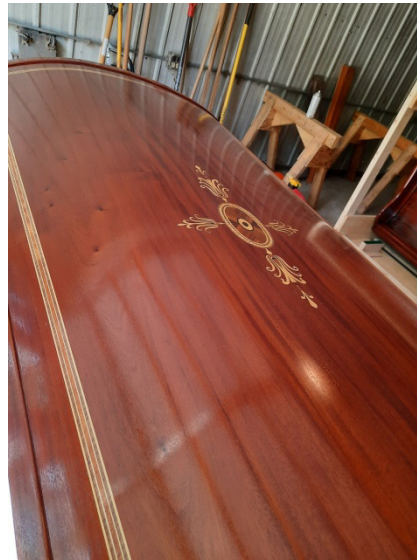
A pair of the original upper berths after they have been restored and following fresh coats of stain and varnish

- Completed the construction and finishing (staining/varnishing) of the (6) new upper berths
- Completed the construction and finishing (staining/varnishing) (6) new lower berth seat ends
- Applied final finish (stain/varnish) to the (4) original upper berths
- Delivered all of the completed berths, seat ends, seat cushion frames to the museum

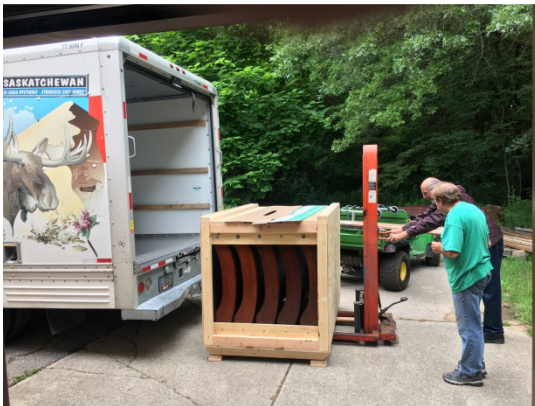
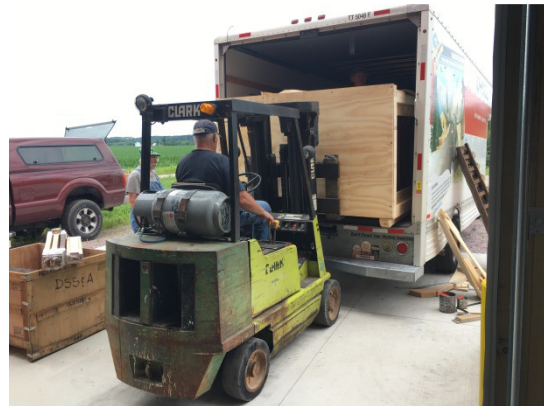
A crate containing (5) of the upper completed berths being loaded in Michigan (L) and unloaded at Mid-Continent (R)

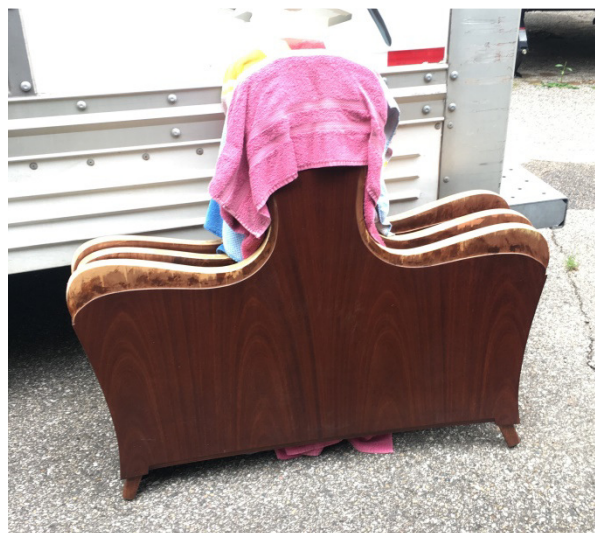
(3) of the (6) new lower berth seat ends getting ready to be loaded and shipped to MCRM

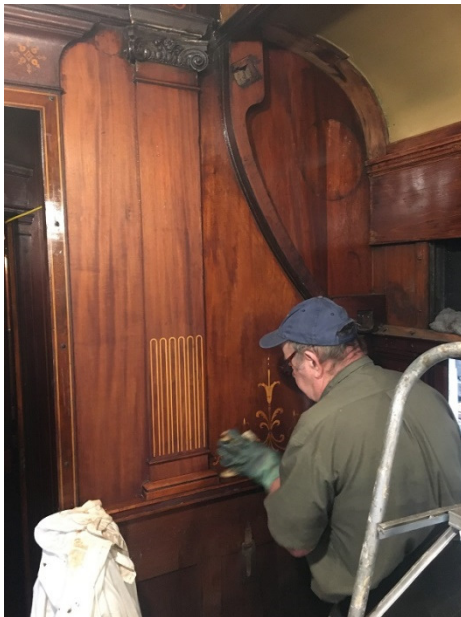
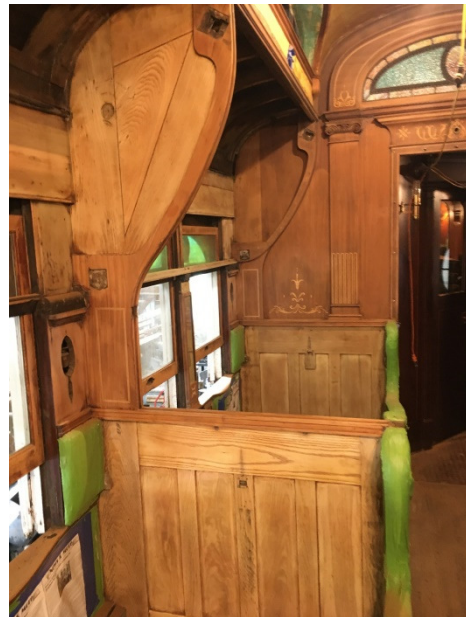
Interior woodwork in the process of being stripped inside the DULUTH

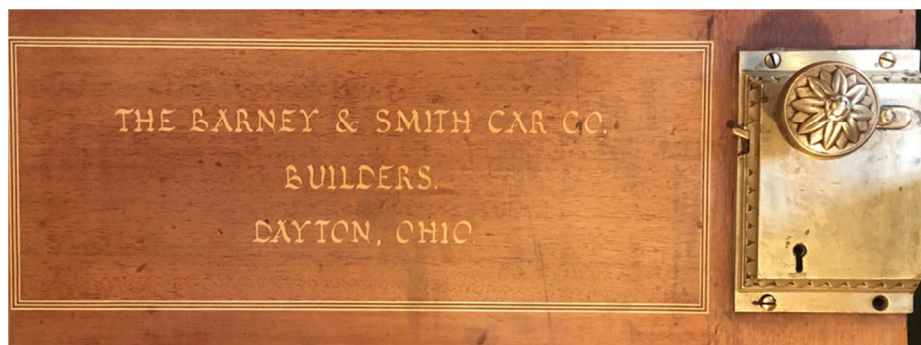
A portion of the end door after being stripped

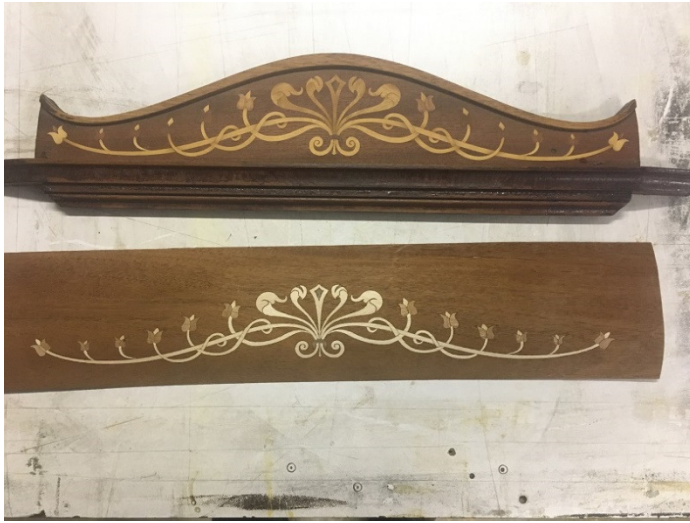
Mirror frame in the process of being replicated. Original frame (top) and replicated marquetry for a new frame (bottom)

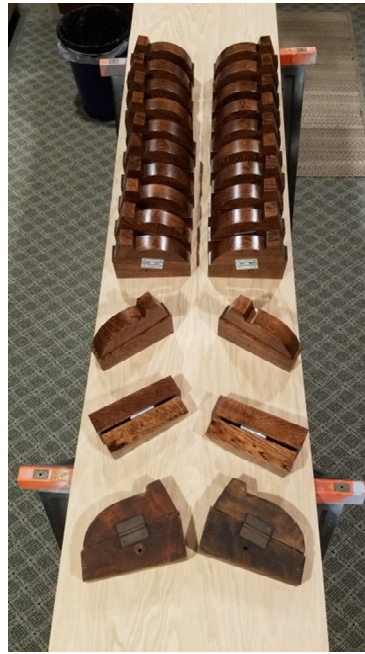
New bottom seat cushion supports

- (12) sets of seat cushion support frames and seat back top rails were made
- (12) pairs of seat cushion support blocks were made and finished
- Test fit the revised berth partition overlay piece (prototype)

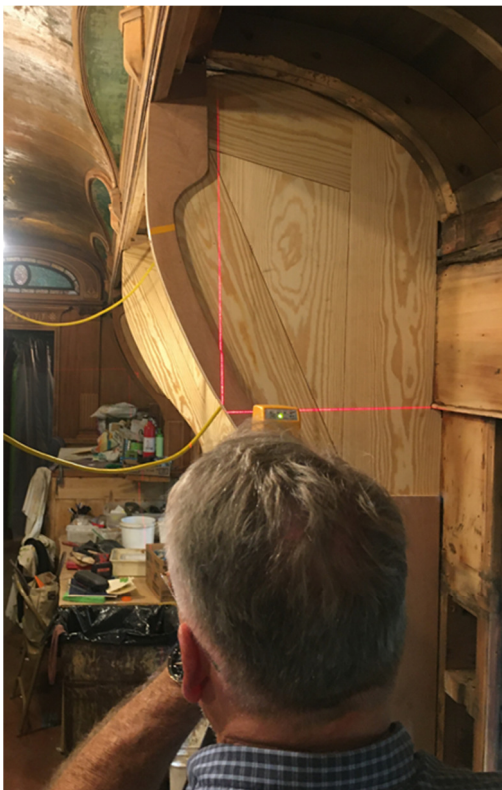
Test fitting the berth partition trim piece in the sleeping compartment with the aid of a laser

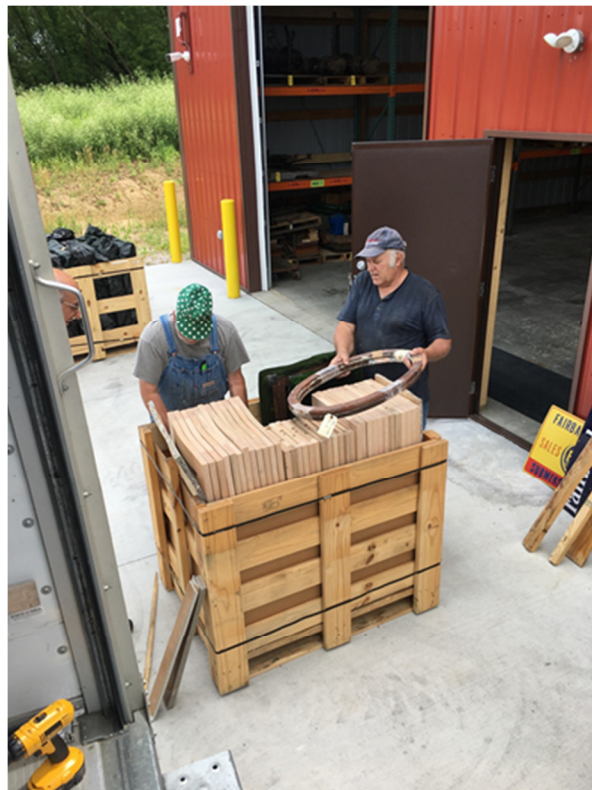
Taking delivery of the replicated oval window frames and the seat cushion frames

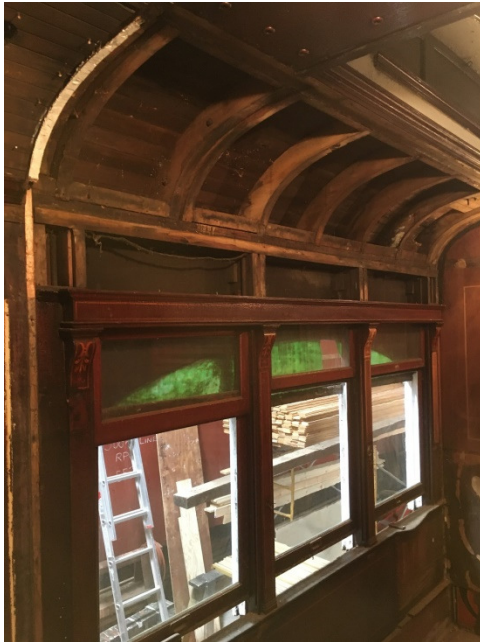
The east wall of the smoking room showing the headliner and upper wall panel removed

- Volunteers have further developed the drawings for the missing Smoking Room and Men's Toilet walls
- Removed the deteriorated headlining panel along the east wall.
- Ordered a replacement wall panel (for above the three windows) that had significant water damage

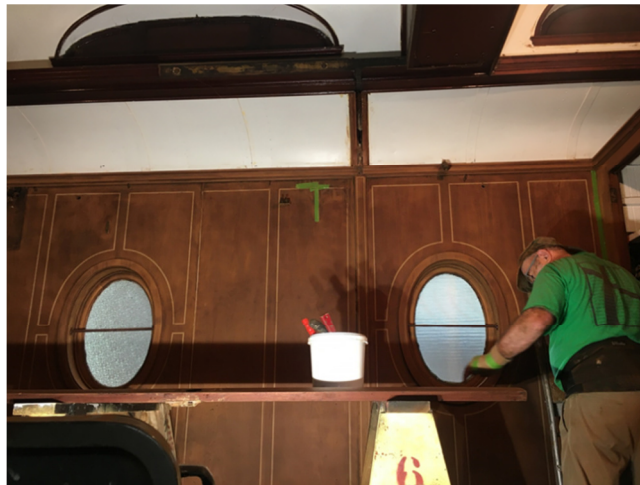
The west wall of the car across from the smoking room showing the stripping in process

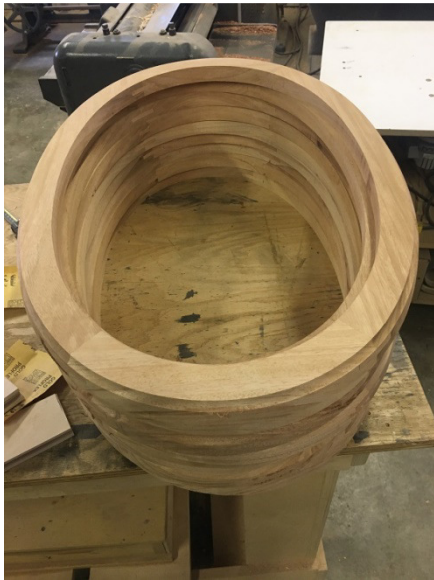
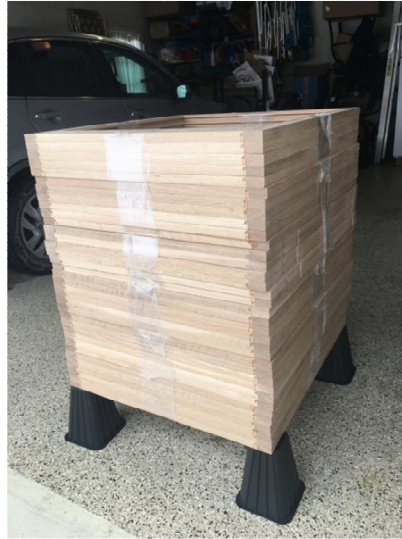
New replica oval window frames (L) and new lower sash window frames (R) made this past year for the DULUTH

- Continued to remove the roof material (rolled asphalt and tar) off of the car. The roof is presently approximately 75% stripped and the majority of the wood on the roof deck appears to be in very good condition
- (9) new oval window frames (mahogany) were made
- (25) new outer window frames (mahogany) were made
- 160 feet of new poplar window sills have been made for the car at an area technical college
- We have started to remove some of the deteriorated wood siding and trim from the car

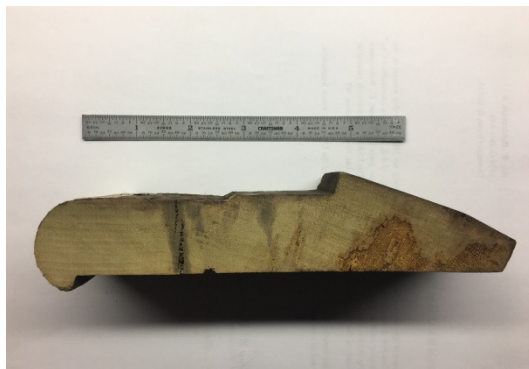
The cross-section of the original window sill

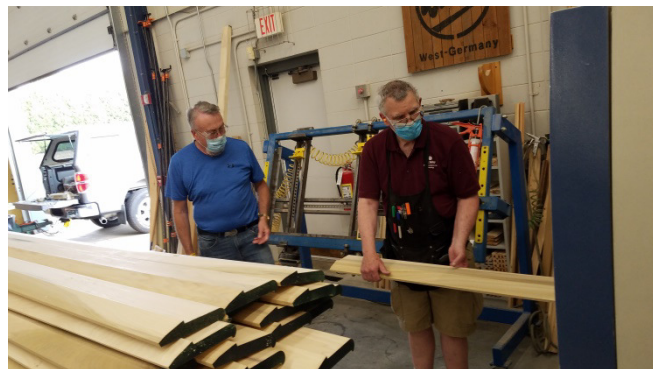
Making the new window sills at an area Technical College

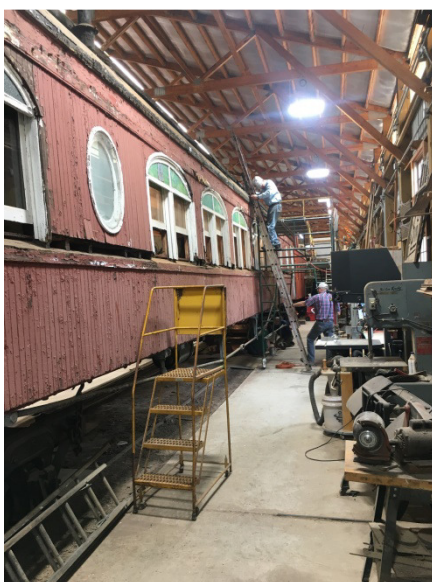
View of the lower roofing being removed

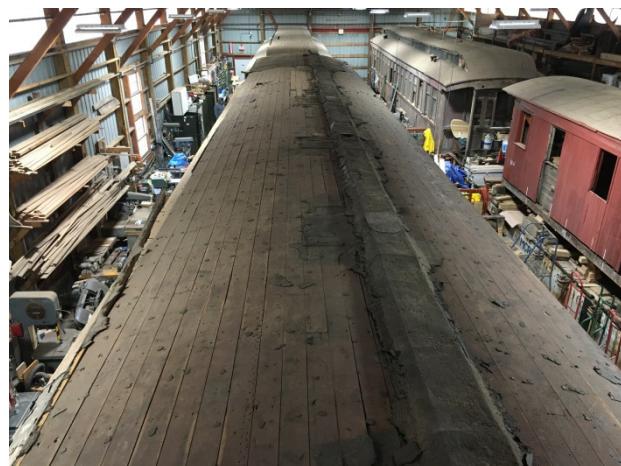
The upper roof deck after the roofing material has been removed

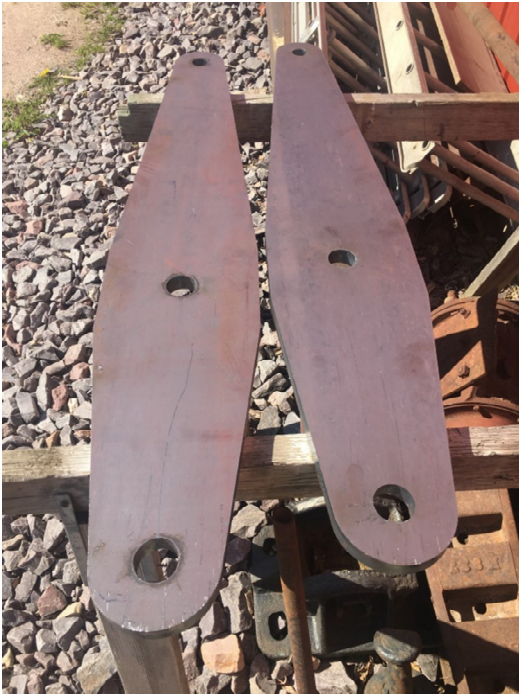
Two of the new brake cylinder levers that were made. The steel levers are 1 inch thick and 36 inches long

- Completed the fabrication and installation of all of the air brake cylinder levers and rods
- Tested the functionality of the air brakes
- Finalized the hand brake system design
- Completed the installation of all of the hand brake levers, rods , supports and guides under the car
- Remaining work on the hand brakes involves installing the hand brake levers (handles), stems and support bracket in each vestibule

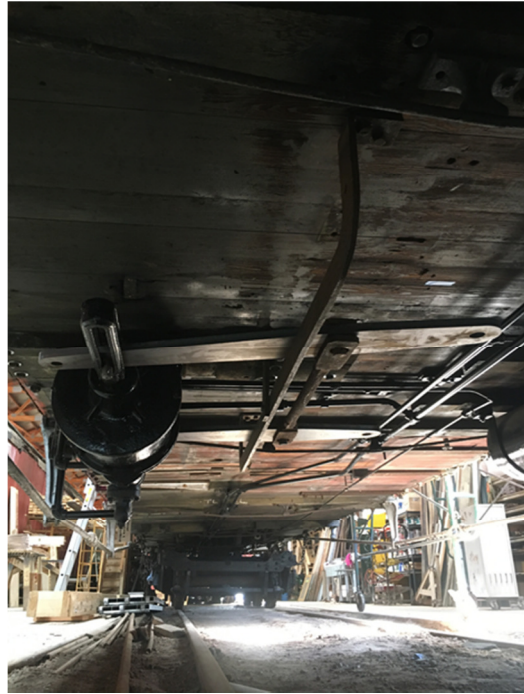
The bottom side of the DULUTH showing the air cylinder with the new levers, rods and hangers installed

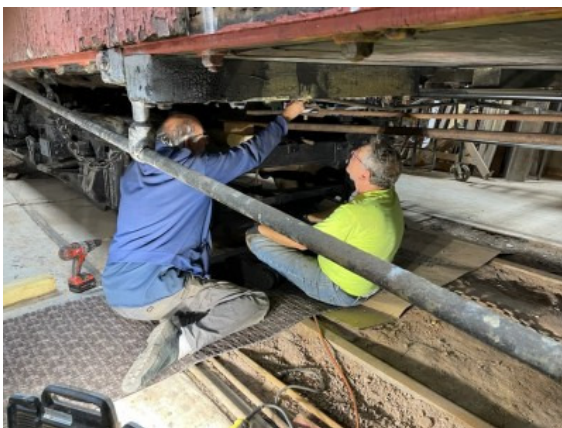
Volunteers installing some of the hand brake brackets

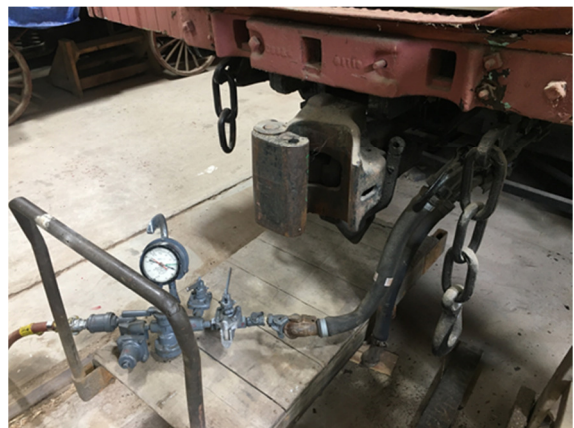
View of the air brakes being tested on the DULUTH

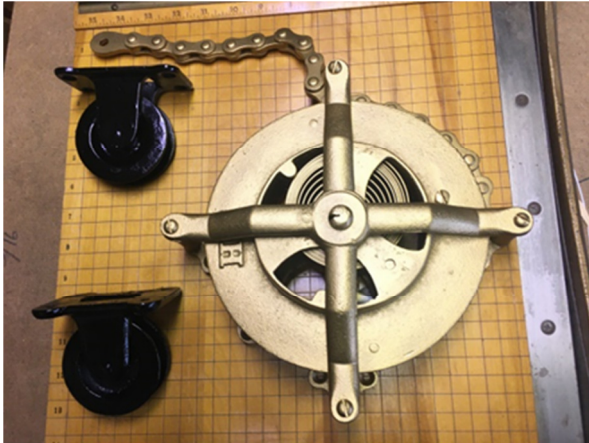
Restored Berth Pulley mechanism

- Cleaned, restored and delivered over 400 pieces of berth and sleeping compartment hardware
- Presently 95% of the berth and sleeping compartment hardware has been obtained, reconditioned and restored
- Cleaned and restored the hardware and rollers for the (25) window shades
- Secured a Baker heater for the car. The original one had been previously removed from the car

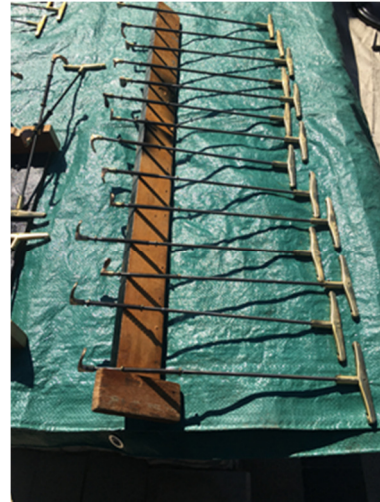
Restored and polished window shade hardware

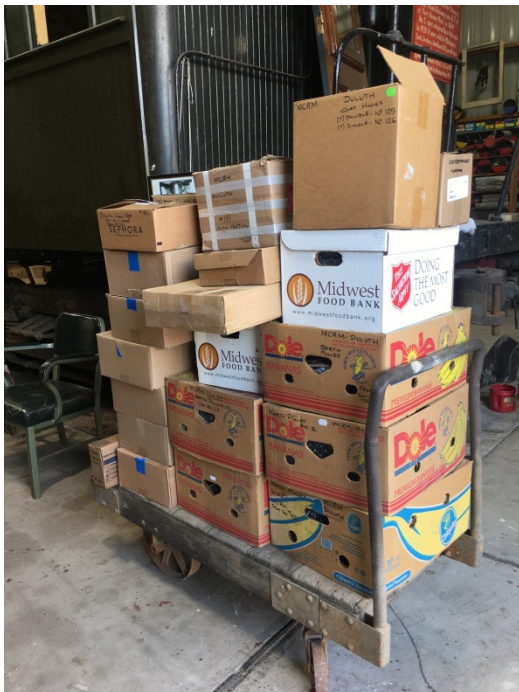
Boxes containing over (400) pieces of restored berth hardware

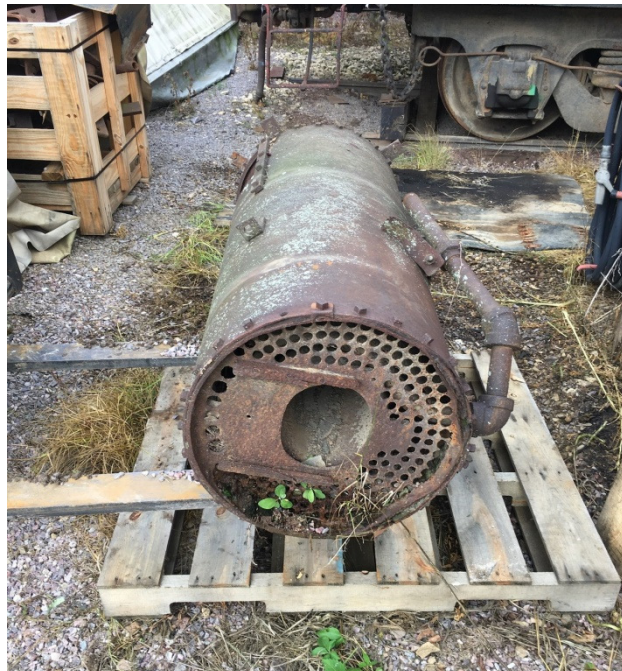
Baker Car Heater acquired for use in the DULUTH. Awaiting restoration
