DSS&A DULUTH SLEEPING CAR RESTORATION 2023 PROGRESS REPORT

MID-CONTINENT RAILWAY MUSEUM

NORTH FREEDOM, WI

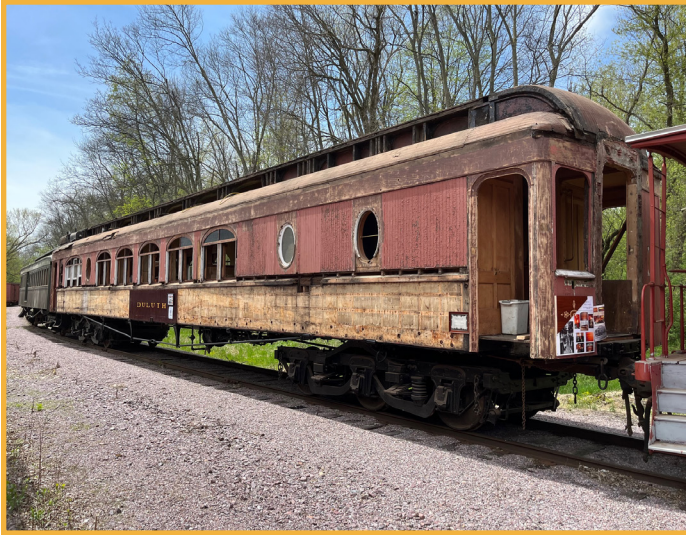
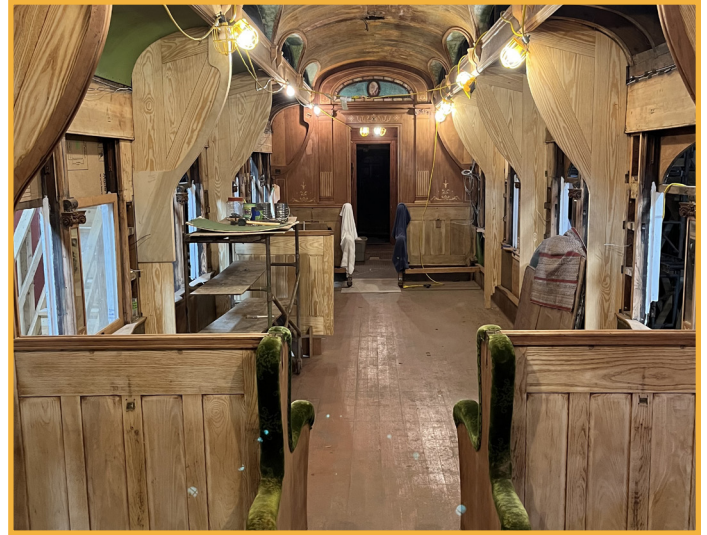
These photos capture the status of the DULUTH sleeping car project at the beginning of the year.

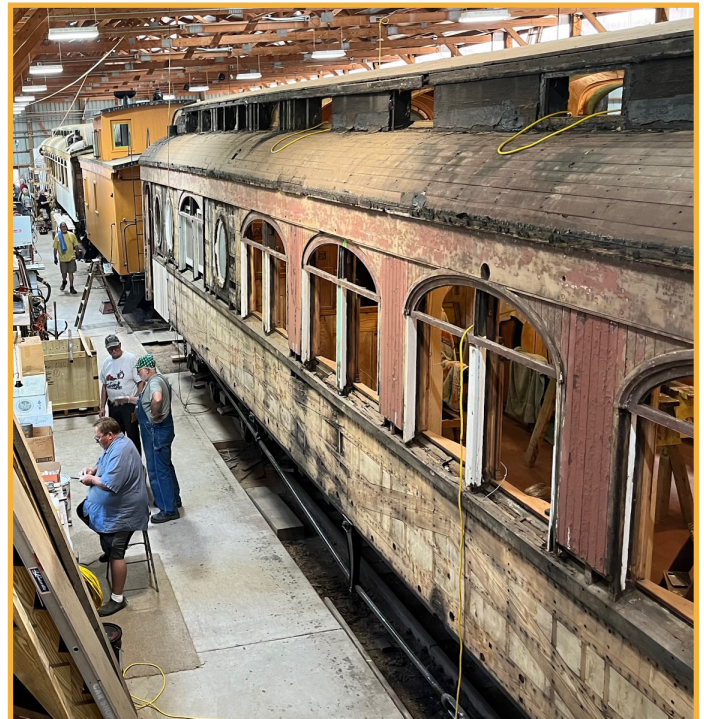
Before the upper siding was removed.

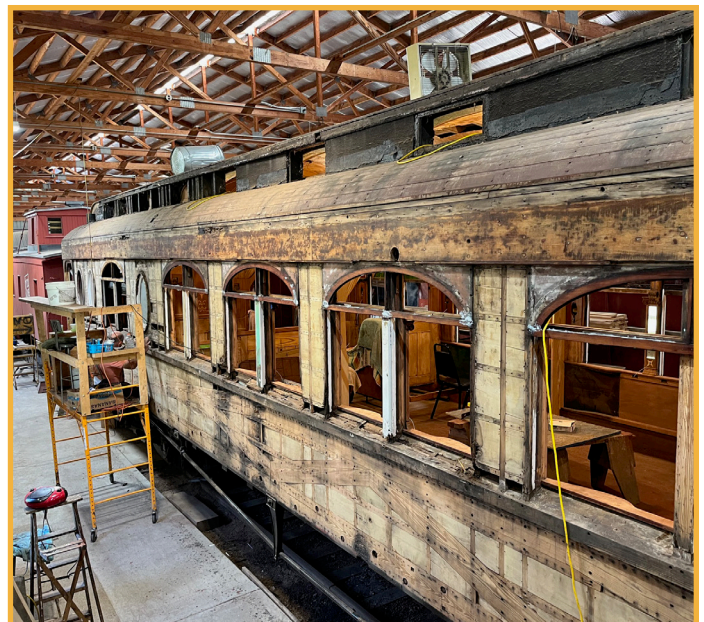
After the upper siding was removed.

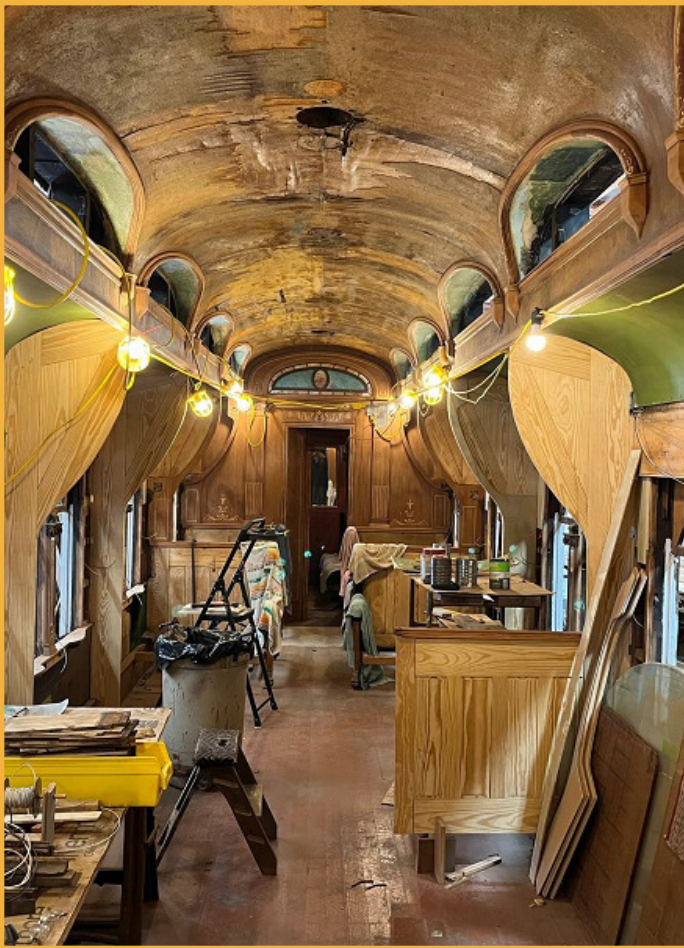
Before the middle portion of the upper ceiling was removed.

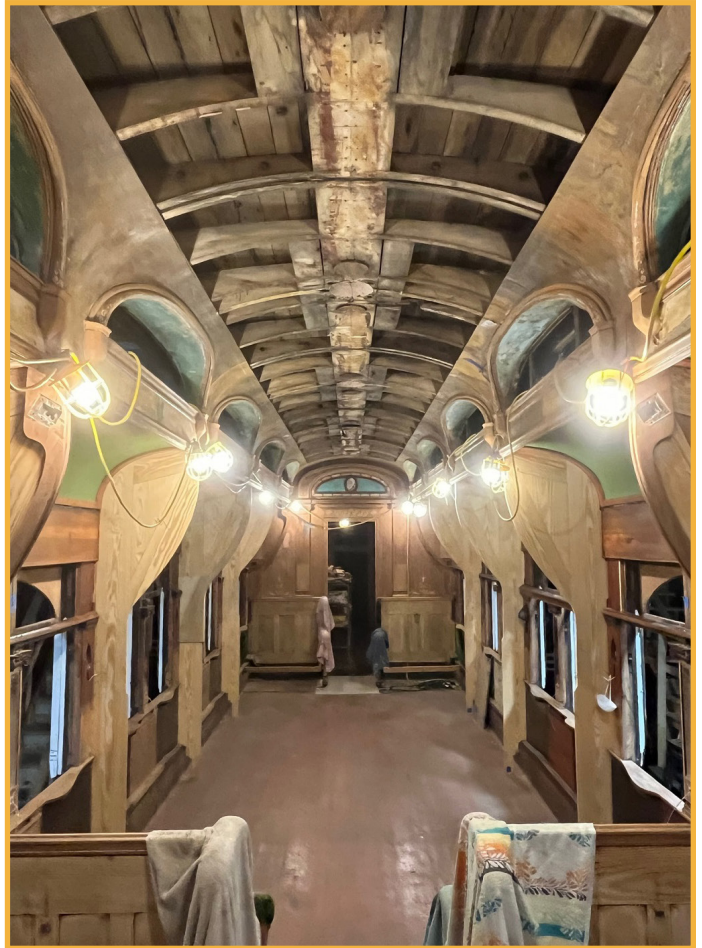
After the upper ceiling was removed.

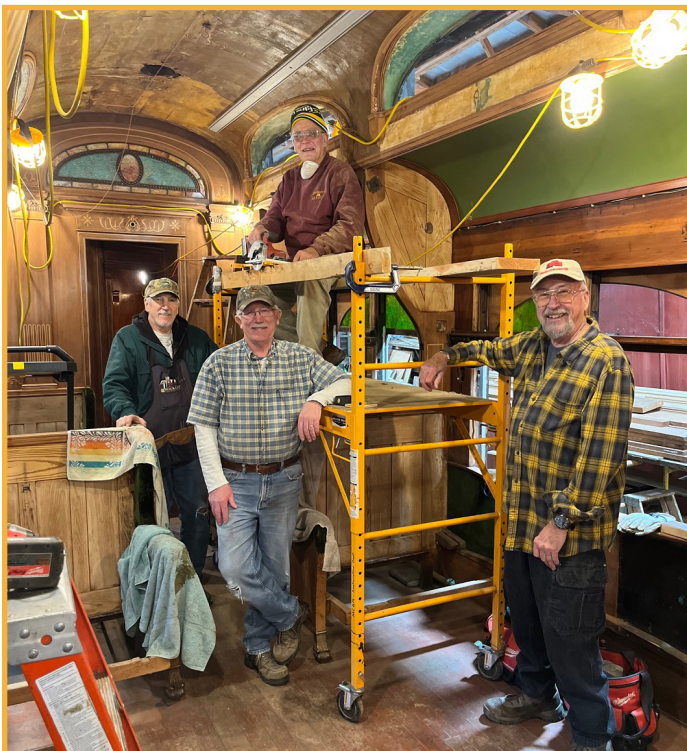
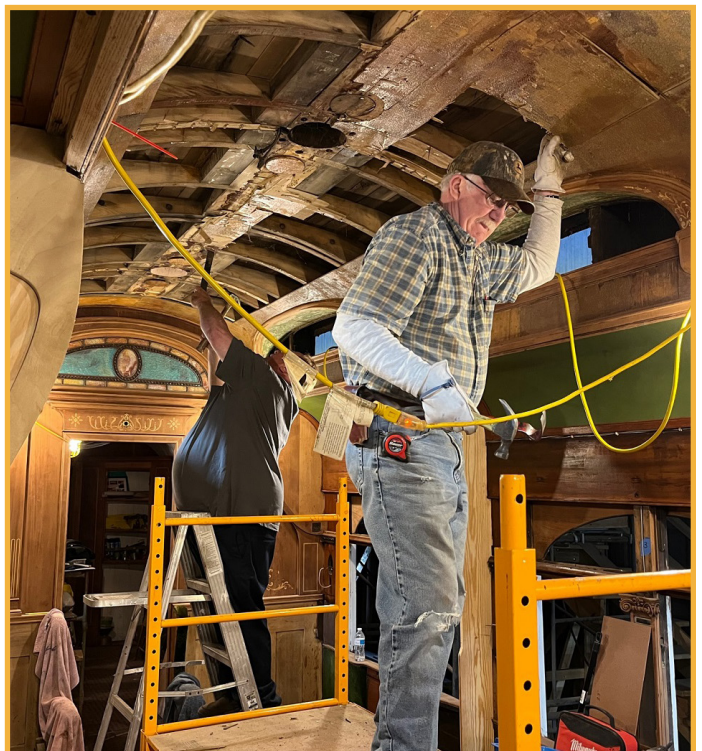
The volunteer crew working on cutting and removing the deteriorated portion of the upper clerestory ceiling.

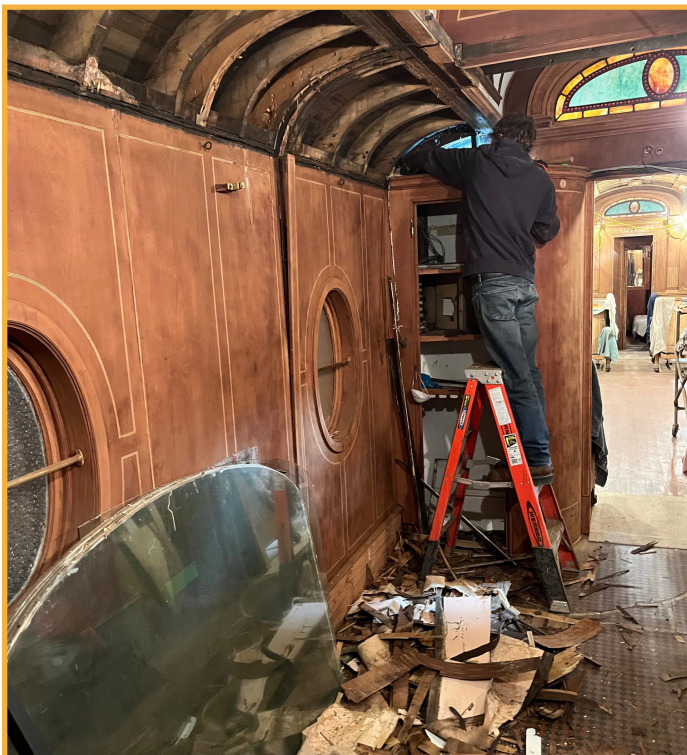
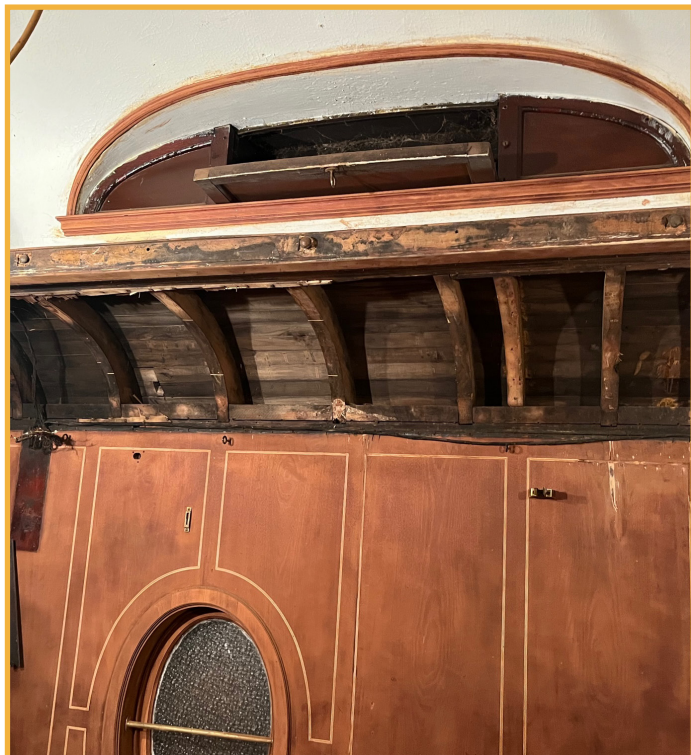
The deteriorated headliner in the process of being removed from the lower roof across from the smoking room.

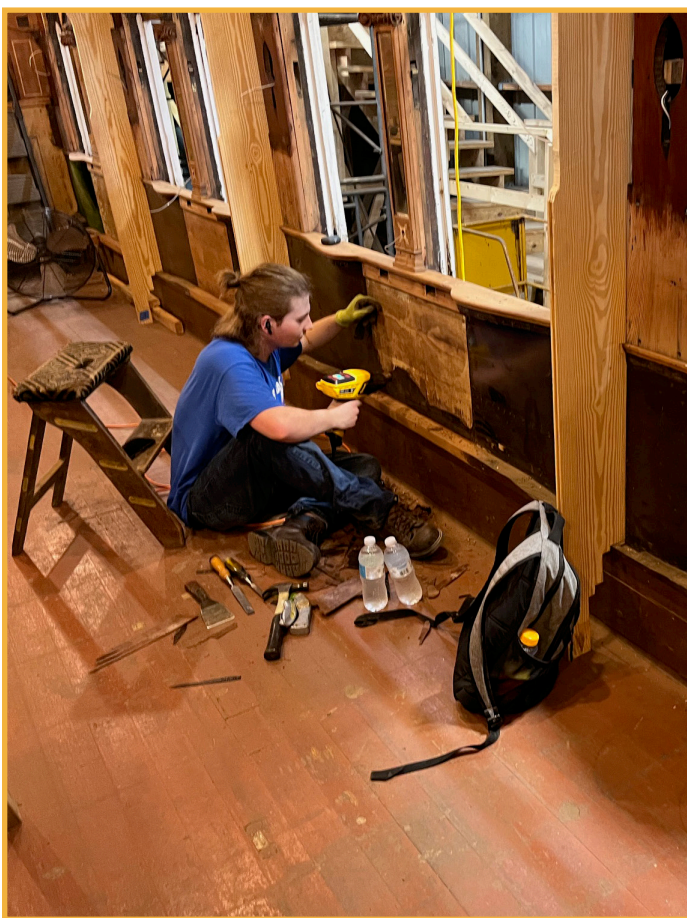
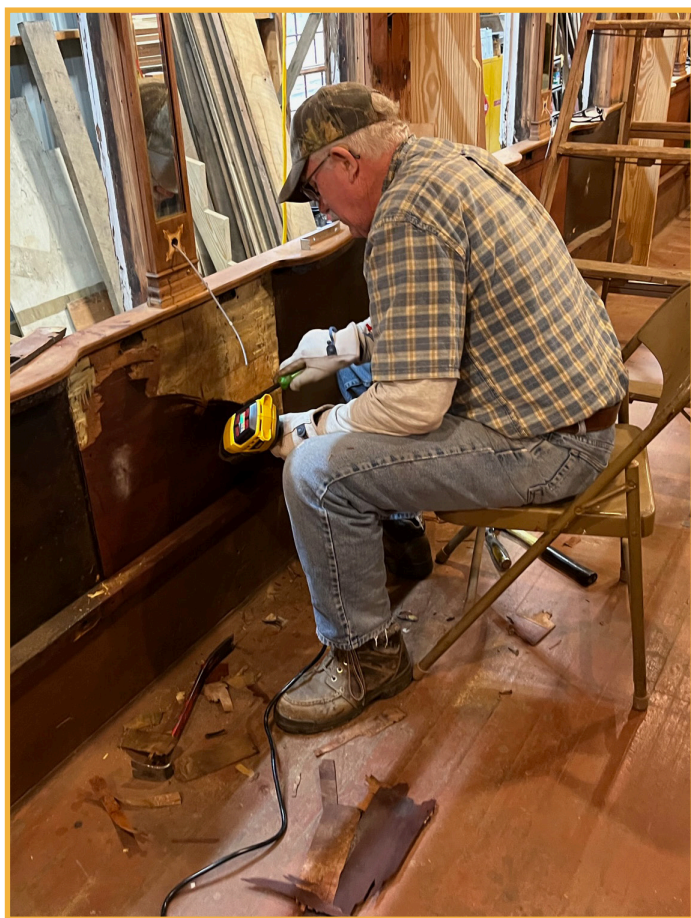
Volunteers removing deteriorated veneer pieces from below the windows in the sleeping compartment.

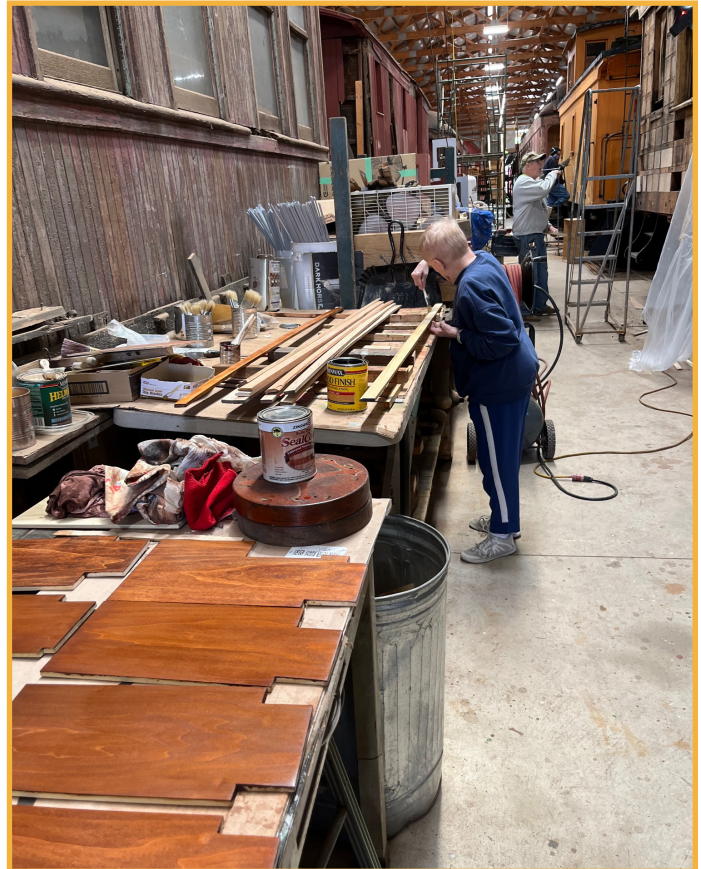
Refinished wood pieces for the window posts.

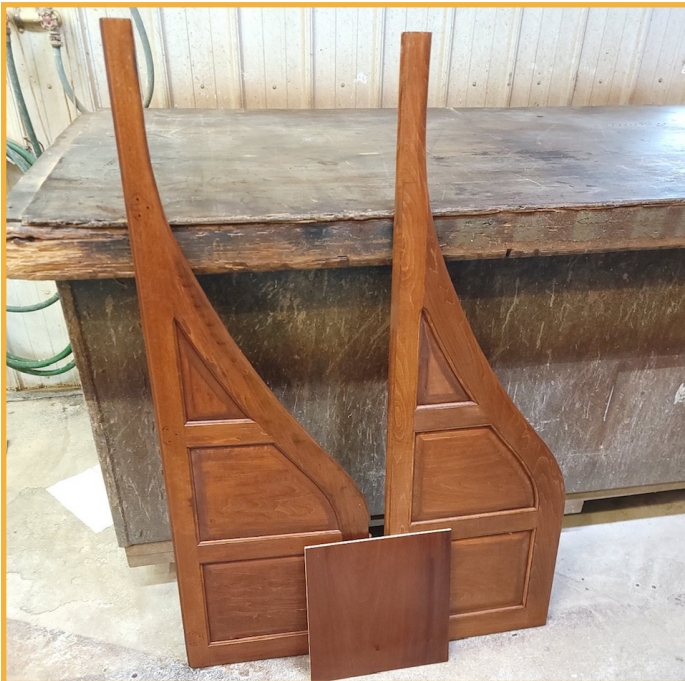
Two of the refinished berth headboards.

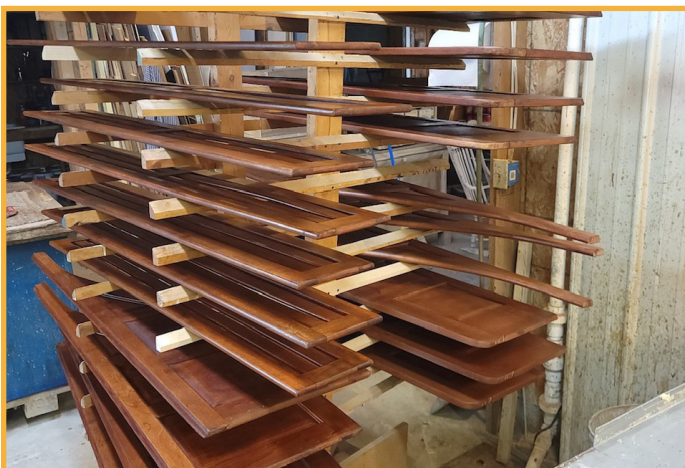
A storage shelf with the refinished headboards and berth racks.

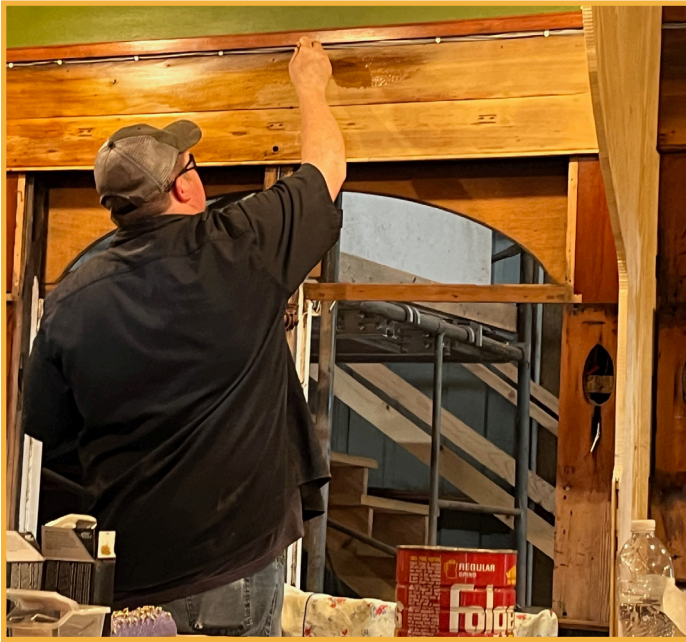
Interior woodwork being refinished.

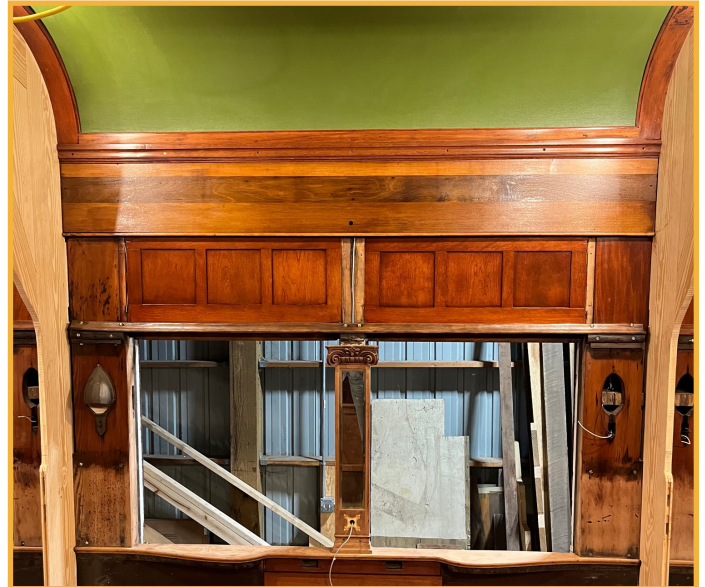
The berth side walls with the headliners and wood blinds installed. One coat of finish was applied on all of the woodwork.

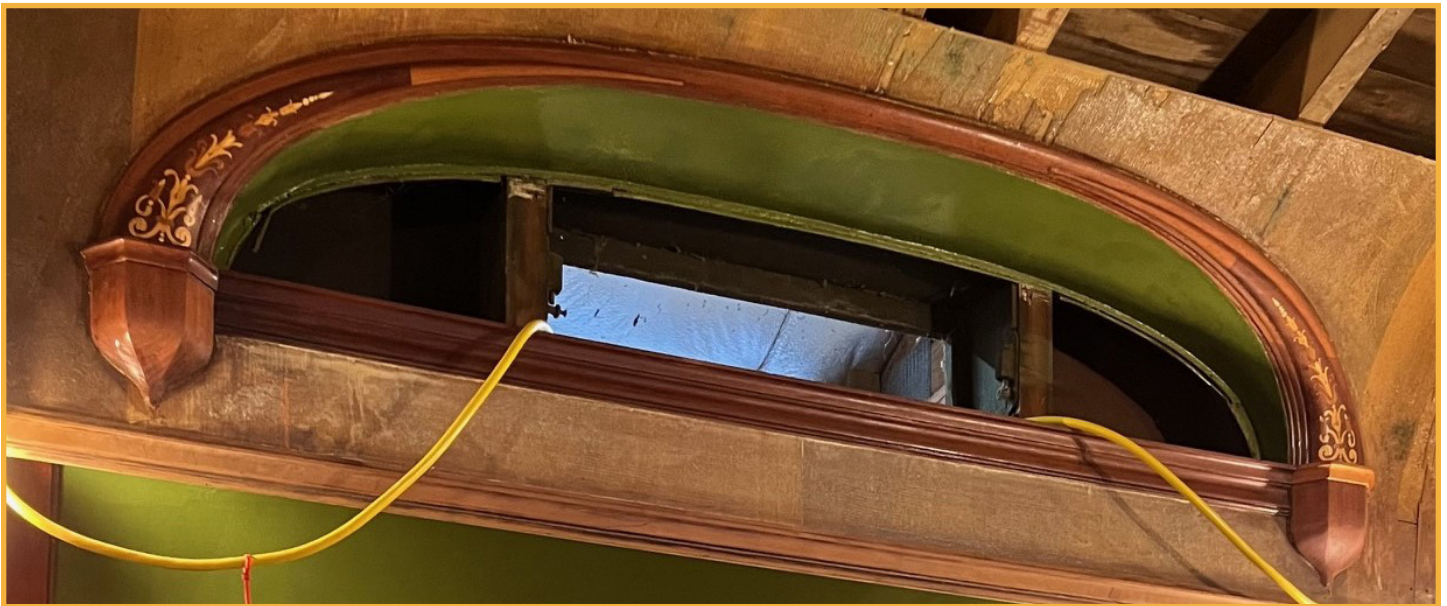
One of the clerestory window openings after being refinished and painting the canvas.

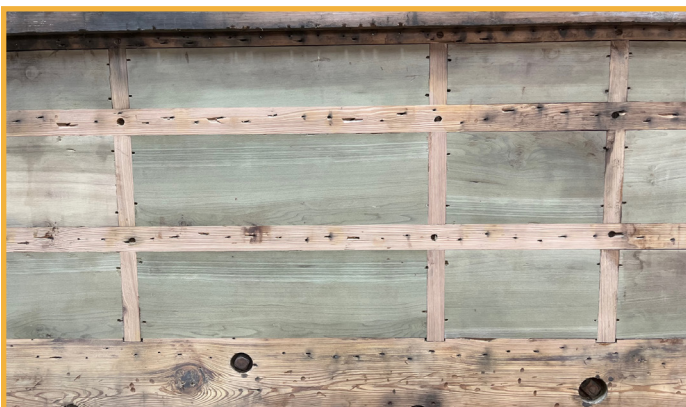
The lower exterior framing after being completely sanded to remove all of the old glue from the car.

The exterior of the car has now been completely stripped down to the framing. This involving removing the old car siding, window stops and window battens. This effort exposed the car framing that was found to be in very good condition with only a couple of exceptions. All of the car framing was sanded to remove all remnants of the old hide glue and prepare the surface for gluing on the new siding. Epoxy repairs were made on all of the arched window frames and the letter board on both sides of the car.

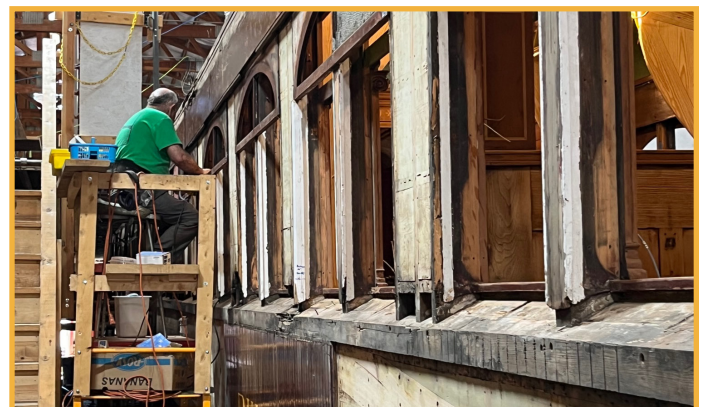
The letter board and arched windows in the process of being filled (epoxy) and sanded.

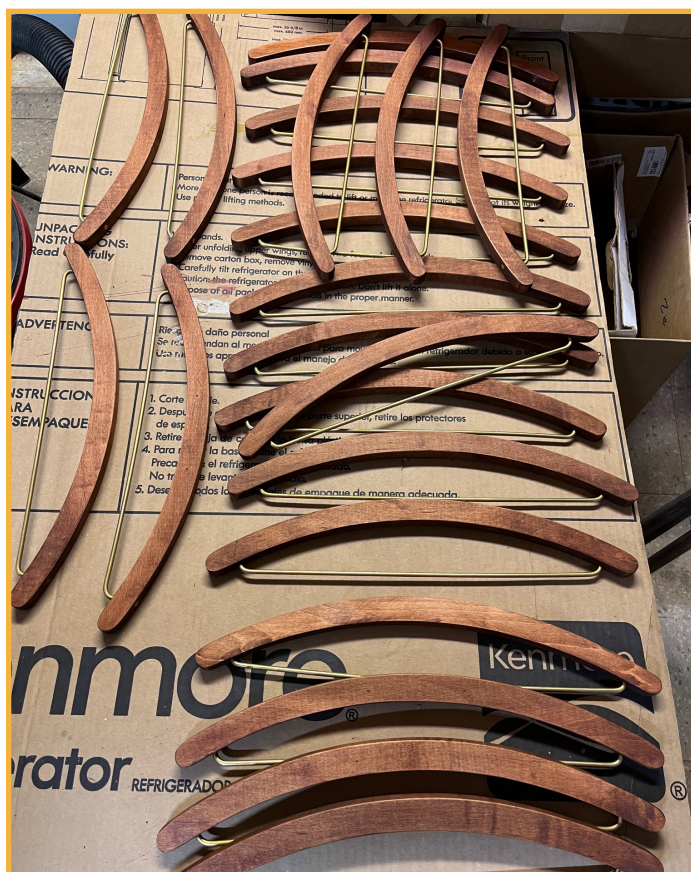
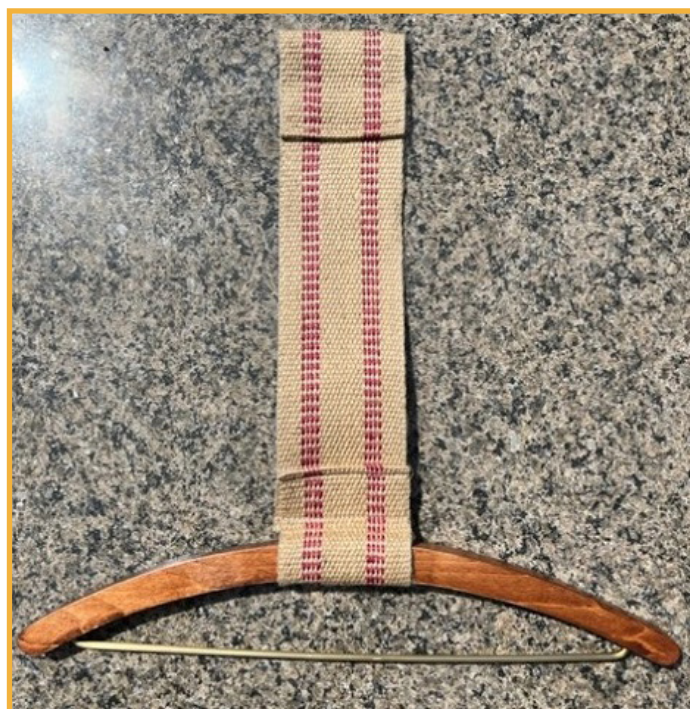
Wooden coat hangers were replicated for the upper berths.

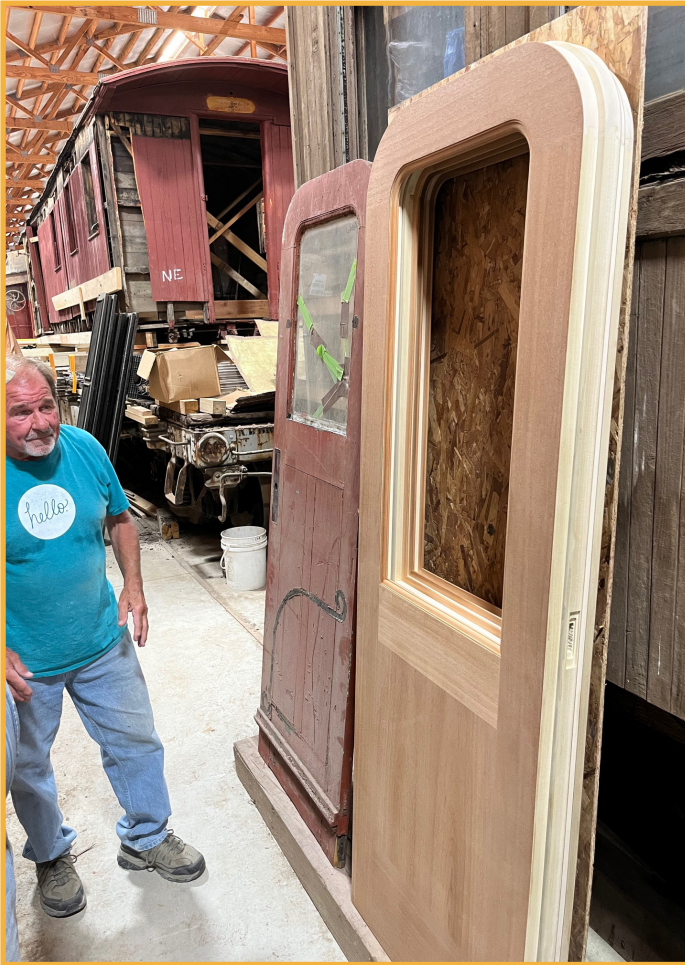
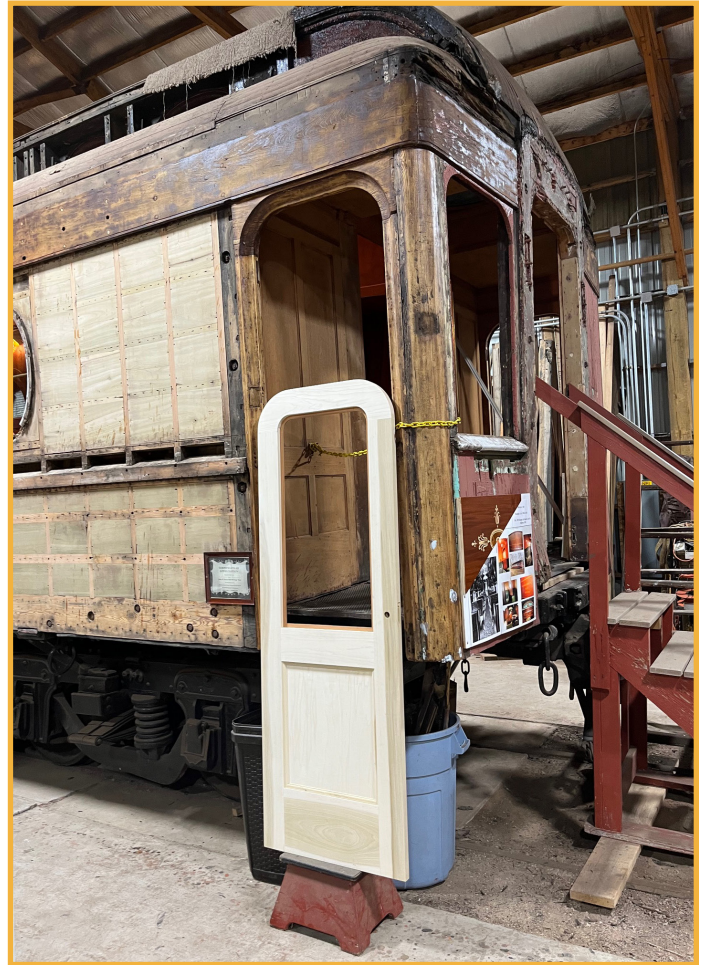
Four new vestibule doors were made to match the original design that featured a larger window size. Left photo: 1918 era replacement vestibule door (L) next to the reproduced original design door. (R)

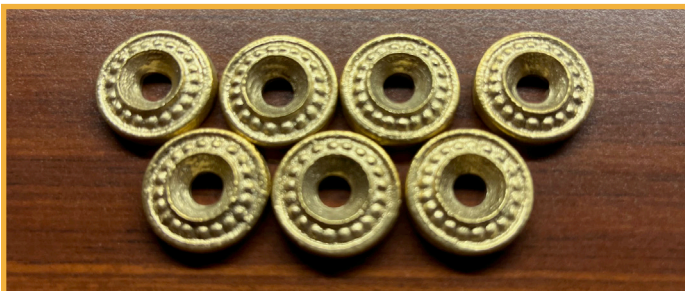
Newly cast brass grommets for the shade boxes.

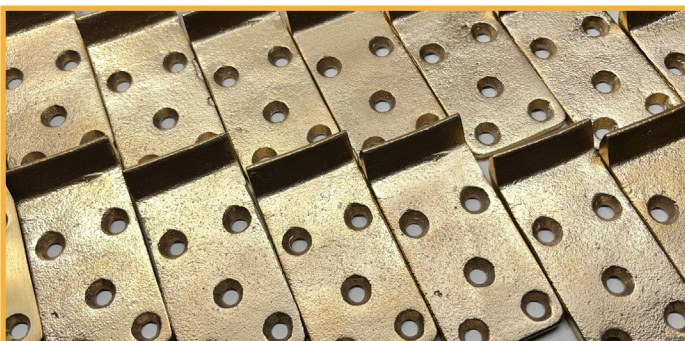
Table brackets made for the berth tables.

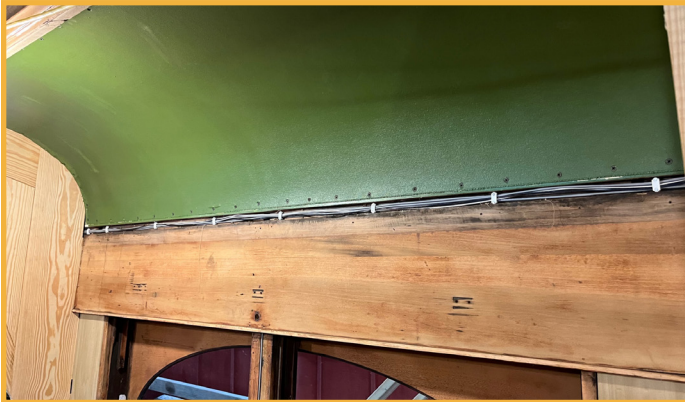
Newly installed electrical and annunciator wiring routed below the headliner panels in the sleeping compartment.

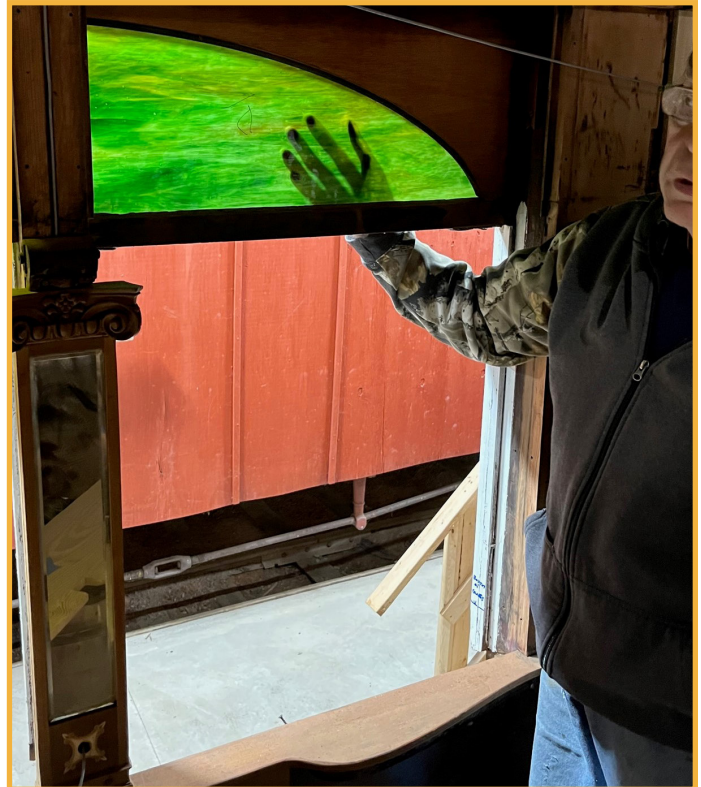
One of the new pieces of stained glass that was cut to size for the sleeping compartment of the DULUTH.

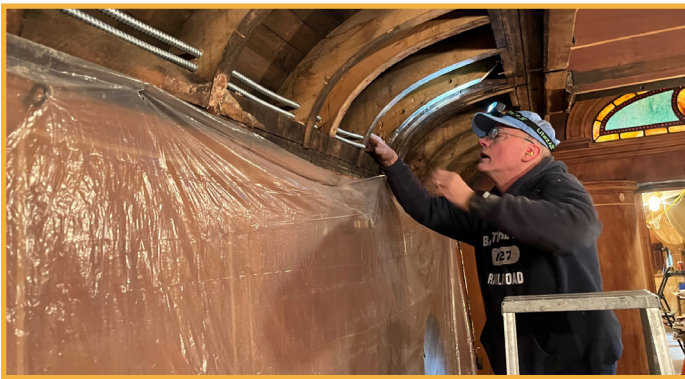
A volunteer installing flexible metallic conduit for the sleeping compartment annunciator wires.

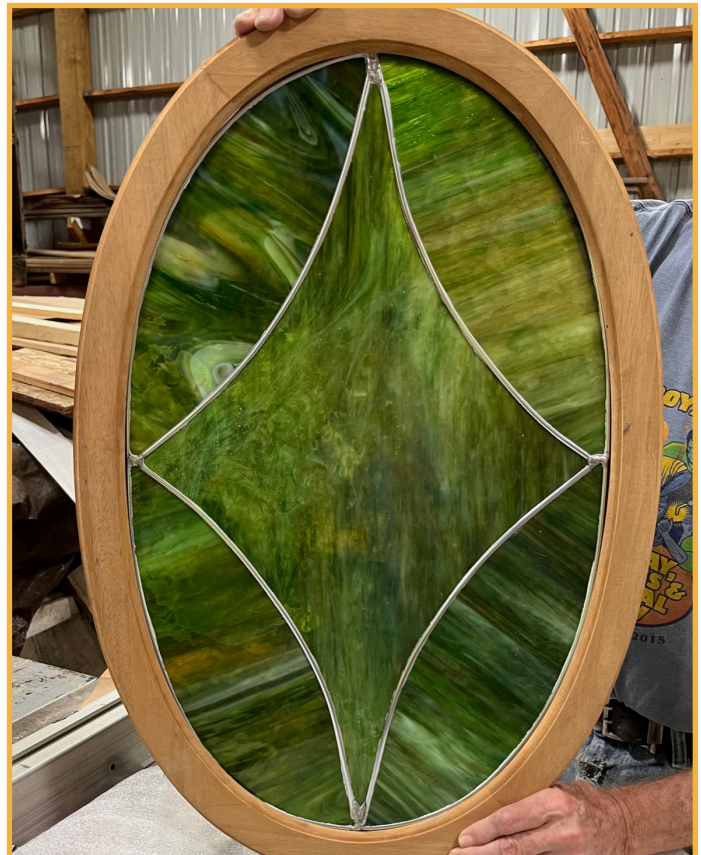
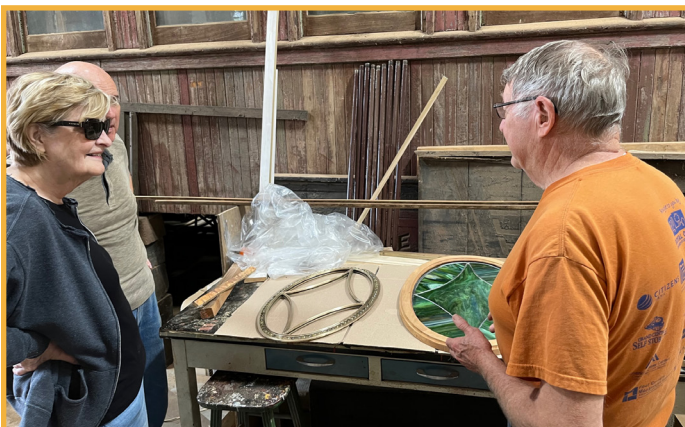
Donors of the DULUTH, Beth and Bob Krasche (L), meet with John Crahen (R) to look at the prototype oval stained glass window he made.
